**Case introduction by Dr. med. Peter Herrmann**, Consultant in the Department of Septic Surgery, Osseous, Articular and Prosthesis Infections, Berufsgenossenschaftliche Unfallklinik, Ludwigshafen

## Prosthesis infection of the knee joints on both sides

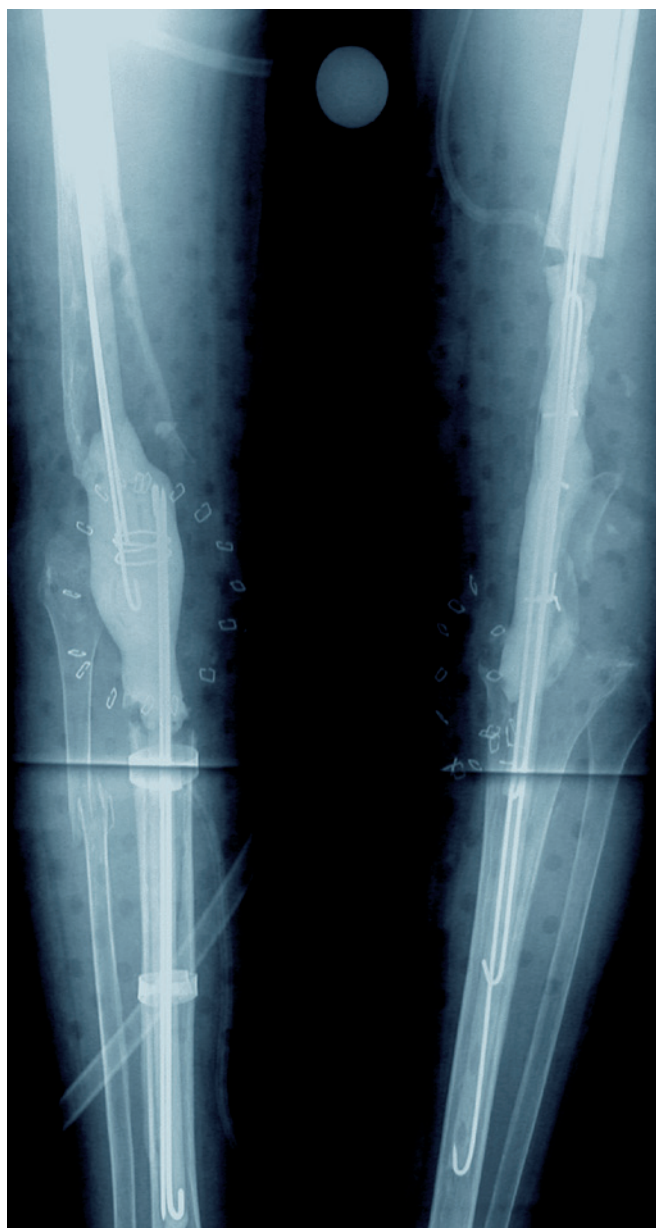
X-ray findings following removal on both sides of revision total knee joint replacement and insertion of spacers

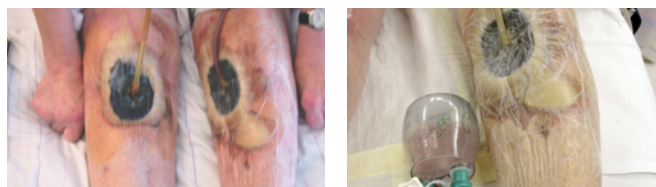
Findings on admission: exposed total knee joint replacement with vacuum sealing of both legs

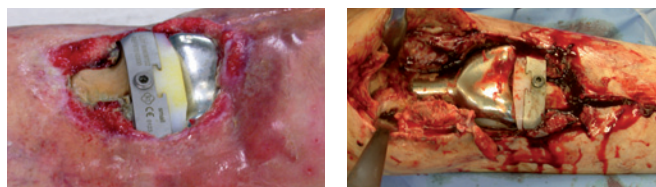
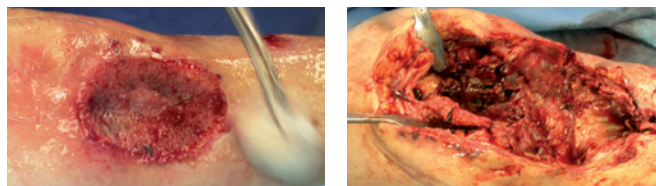
Above left: total right knee joint replacement following removal of the vacuum sealing. Above right: total right knee joint replacement following debridement of soft tissue. Middle left: operation site on the left during the first operation. Middle right: right knee following removal of the total knee joint replacement. Bottom left: findings for the right knee following the first procedure

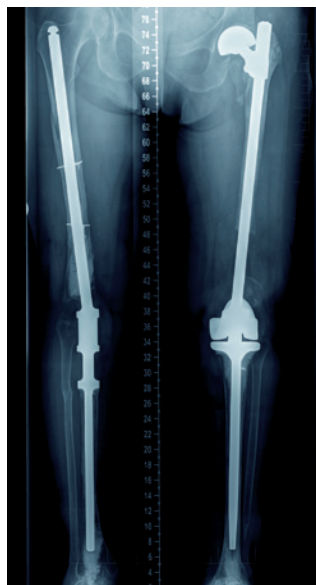
Above: right knee following plastic closure over the spacer. Left: complete images of the legs with the patient standing, dated 11 March 2010; X-ray findings with new implants in both legs

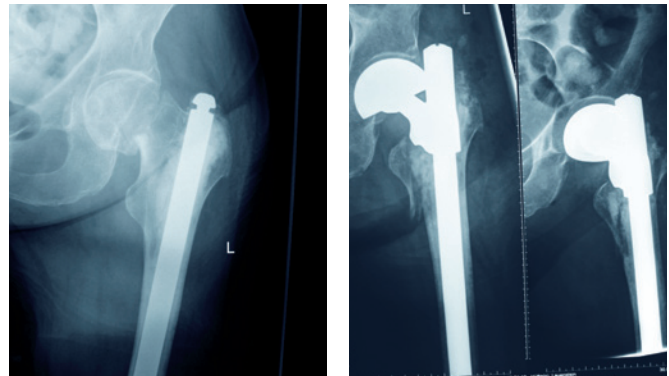
Left: medial fracture of the neck of the femur. Right: left hip after the operation

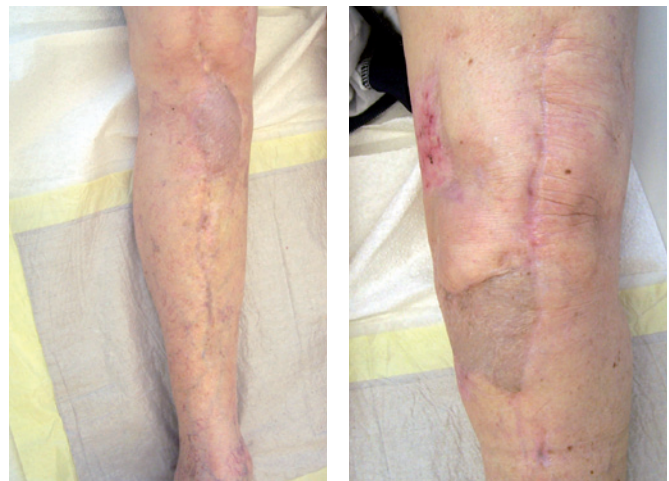
The soft tissue over both knee joints are covered in a stable manner, the multiple split-skin sampling sites are still covered with unstable scars during epithelialisation, however in a normal condition on the whole

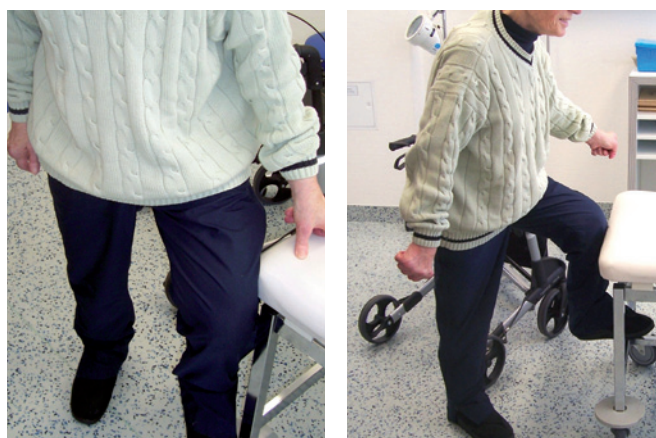
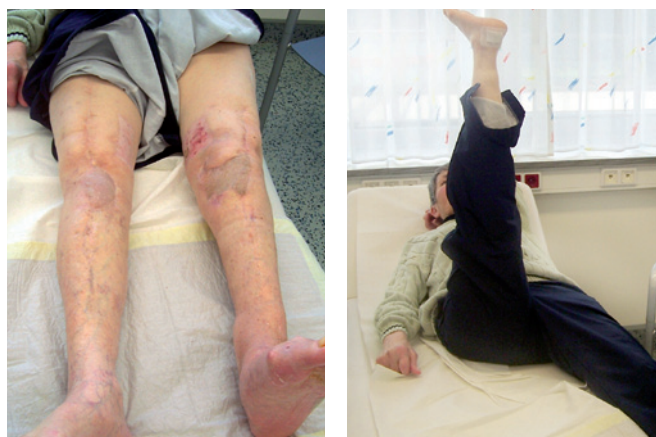
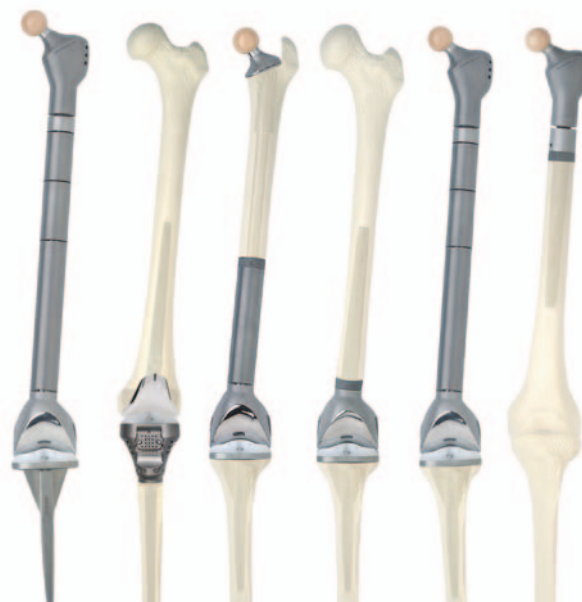
Above: Despite the very serious situation at the outset, the patient was able to bear full weight and full sensation was maintained in both legs, due to the insertion of modern specialized implants and plastic surgery procedures with local flap repair
